REPAIR PARKING GARAGE

LOCATION	Madrid—Spain
DATE OF EXECUTION	2015
ENGINEERING	
CONTRACTOR	Pavior

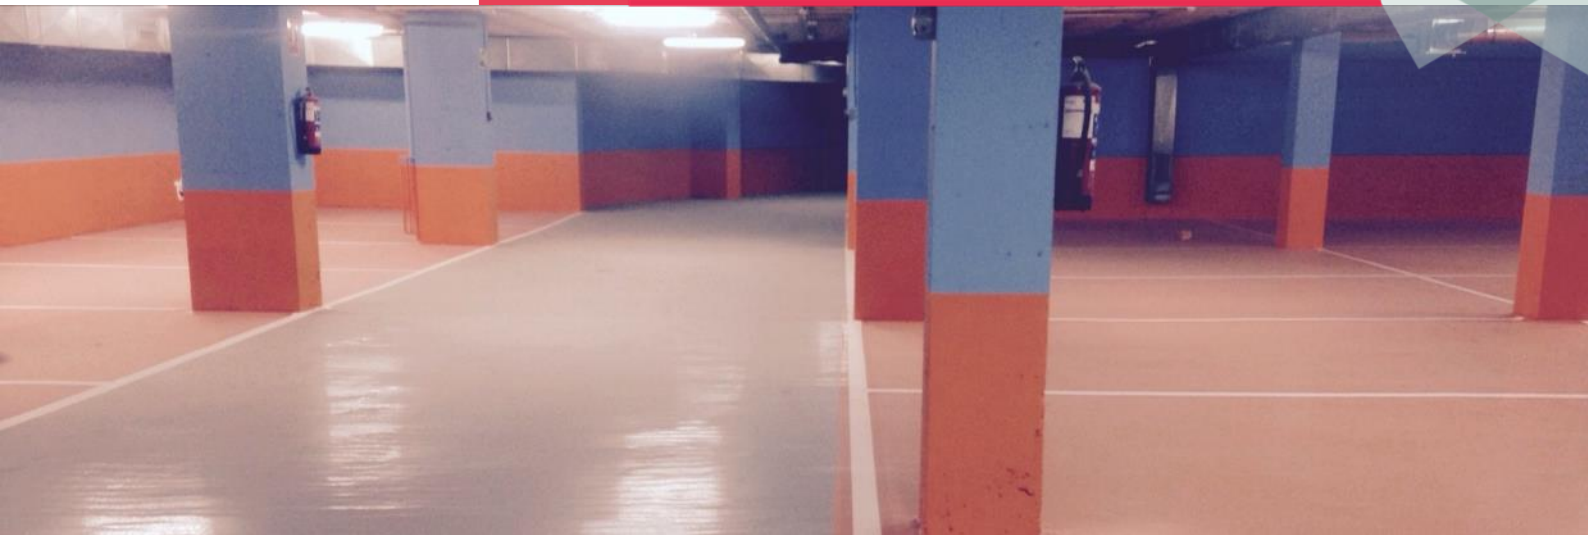
The original concrete floor was severely damaged due to intense traffic, penetration of oil and de-icing salts and deposit of rubber.

The floor was shot blasted in order to remove all contaminated and loose concrete particles. **CEMPRIME AC**, with special formulation for hot temperatures, was used to prepare the surface before installing **CEMTOP 320**. **CEMTOP 320** was formulated with a longer open time because of the hot temperatures. An epoxy coating was used in order to seal the surface.
